Manhole Inspection Summary

Manhole # S01WW1001MH

Insp Date: **10/11/06 1:17 PM**

Location Address: **6200 PARK HEIGHTS AVE**

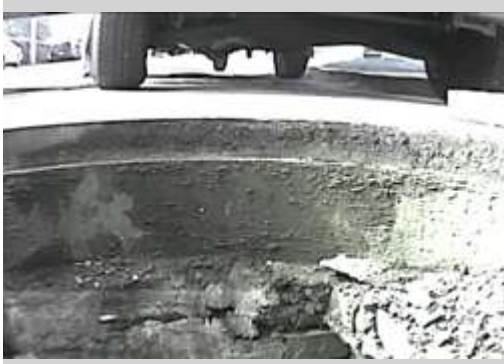
Defect

Offset: **4** (in.)

☒ **Leaks**

Infiltration: ☐ None ☒ **Joint** ☐ Cracks ☒ **Mortar** ☐ Roots ☐ Wall

Frame leaks. Frame offset. Adjustment deterioration and infiltration.

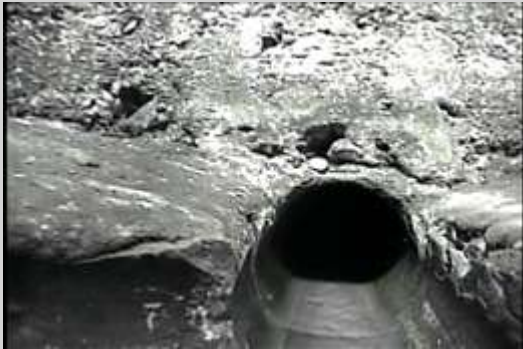
8 in. Circular Gravity Sewer Pipe Out @ 12 O'Clock

Invert Depth: **7.03** (ft.) Flow Characteristics: **Slow**

Infiltration: **Evidence** Pipe Seal Cond: **Unknown**

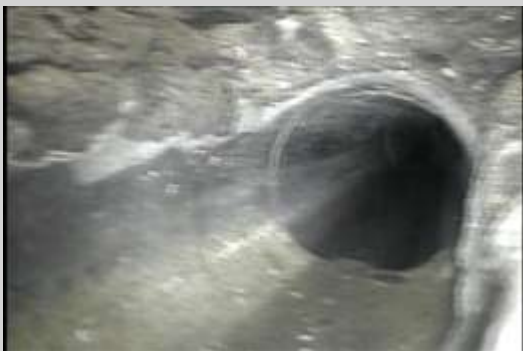
8 in. Circular Gravity Sewer Pipe In @ 6 O'Clock

Infiltration: **None** Pipe Seal Cond: **Sound**

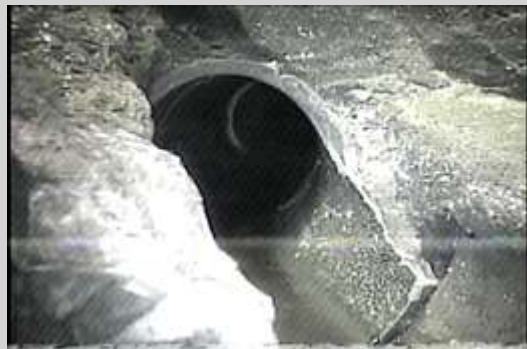
Pipe In @ 9 O'Clock

Infiltration: **None**
